Project Name: Gold King Mine	Site Location: Silverton, San Juan County, Colorado	Project No. 0001/1408-01
--	---	------------------------------------

PHOTOGRAPH LOG

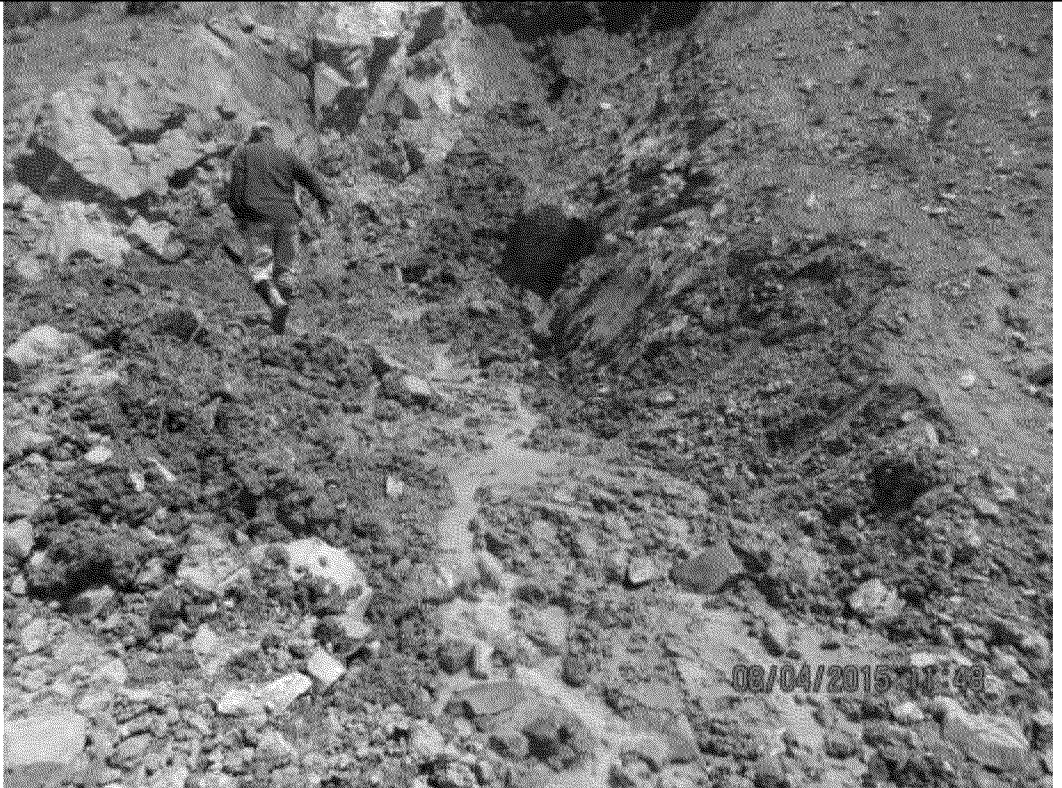
Photo No. 5	Date: 08/04/2015

Direction Photo Taken: North		
Description: DRMS looking at adit excavation progress.		
Photo No. 6	Date: 08/04/2015

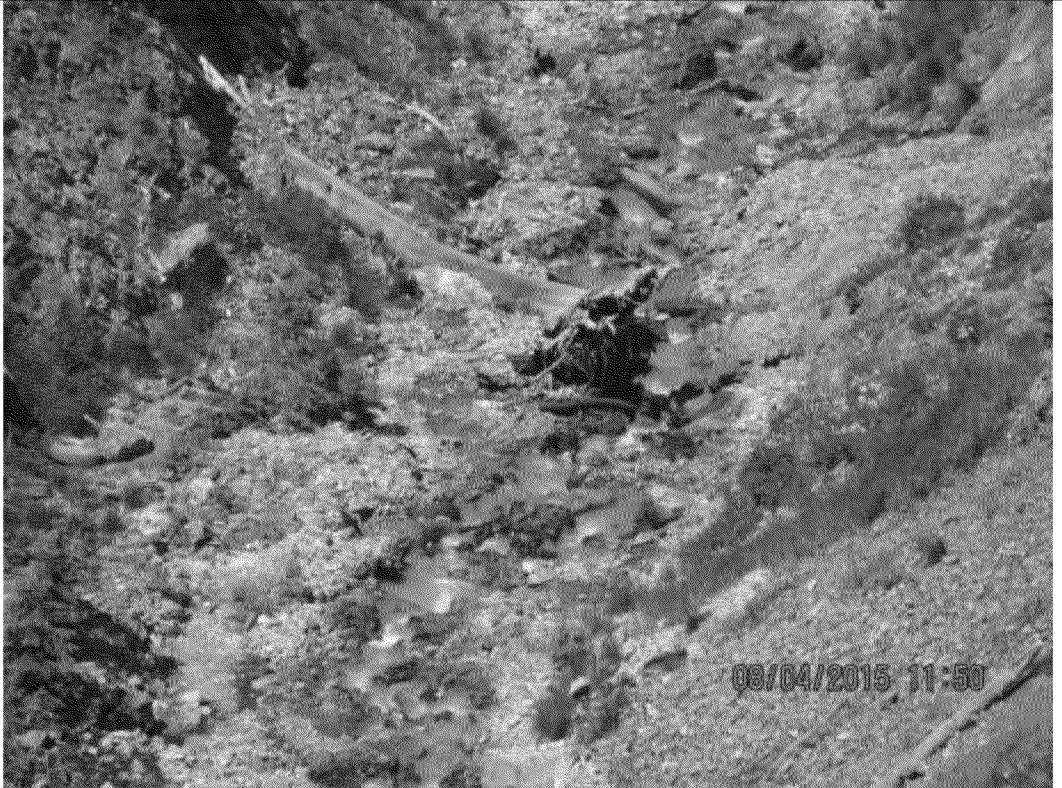
Direction Photo Taken: West		
Description: Water minimally murky from disturbed soil and water entering the North Fork from site.

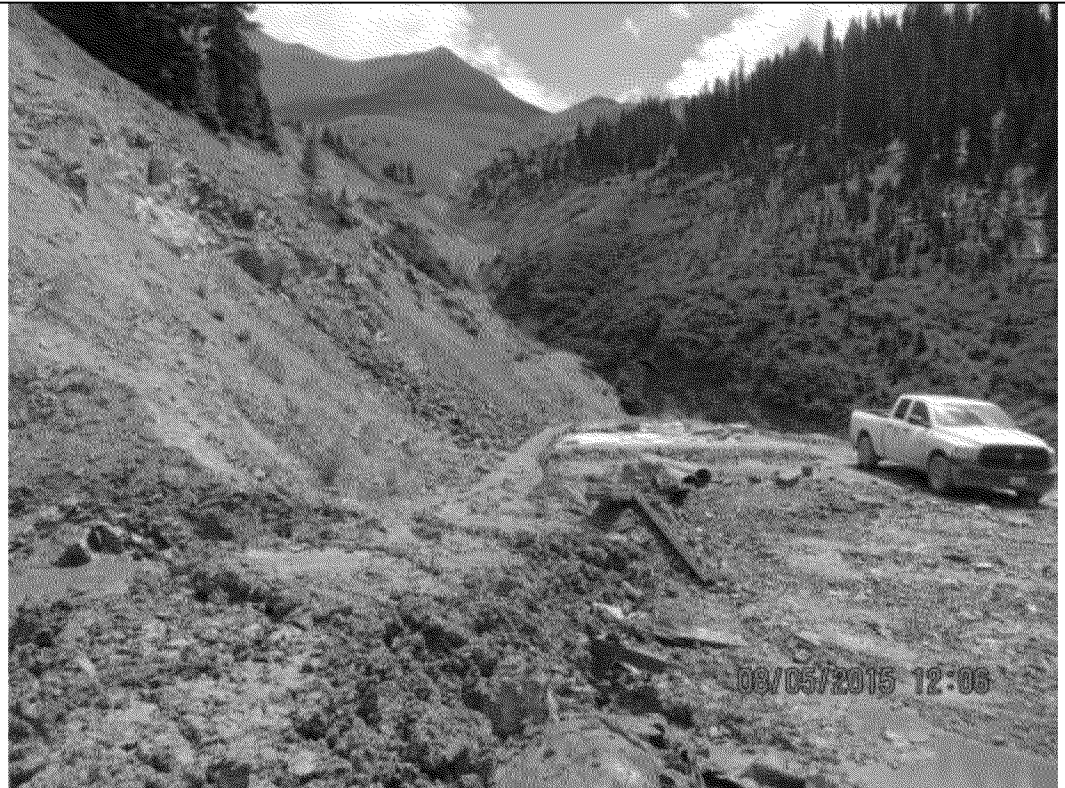
Photo No.
33

Redirected flow into existing half culvert channel.

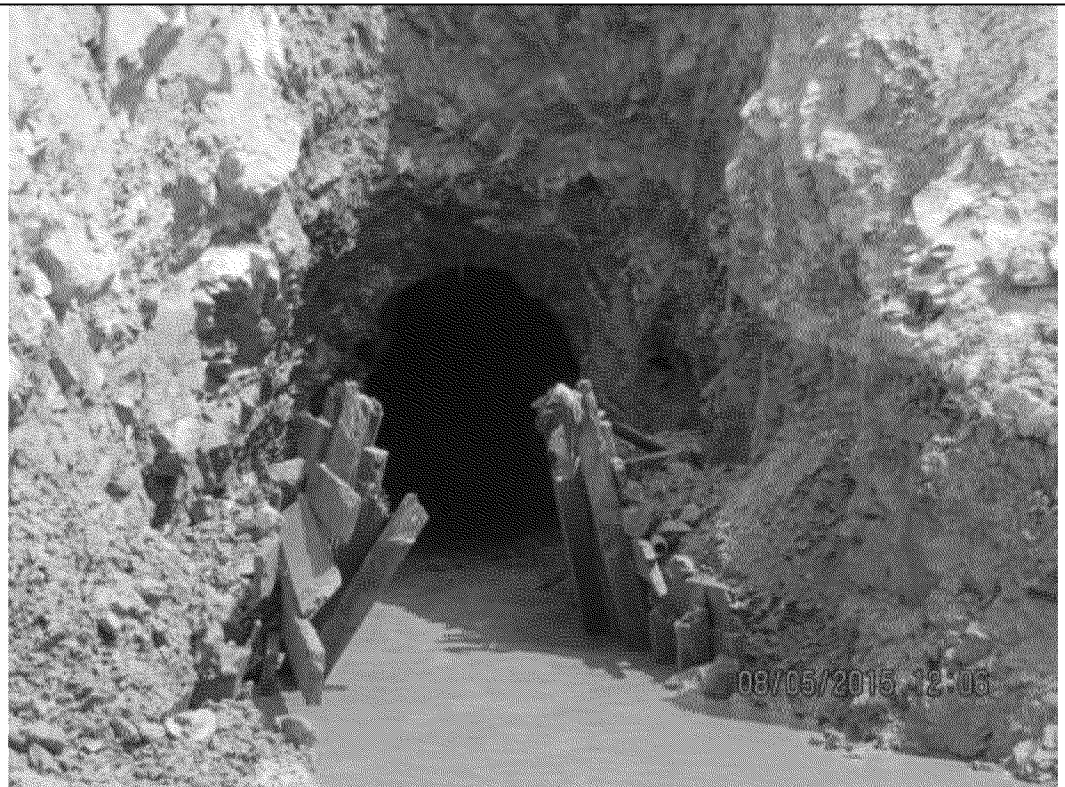
Photo No.
34

Closeup of adit.

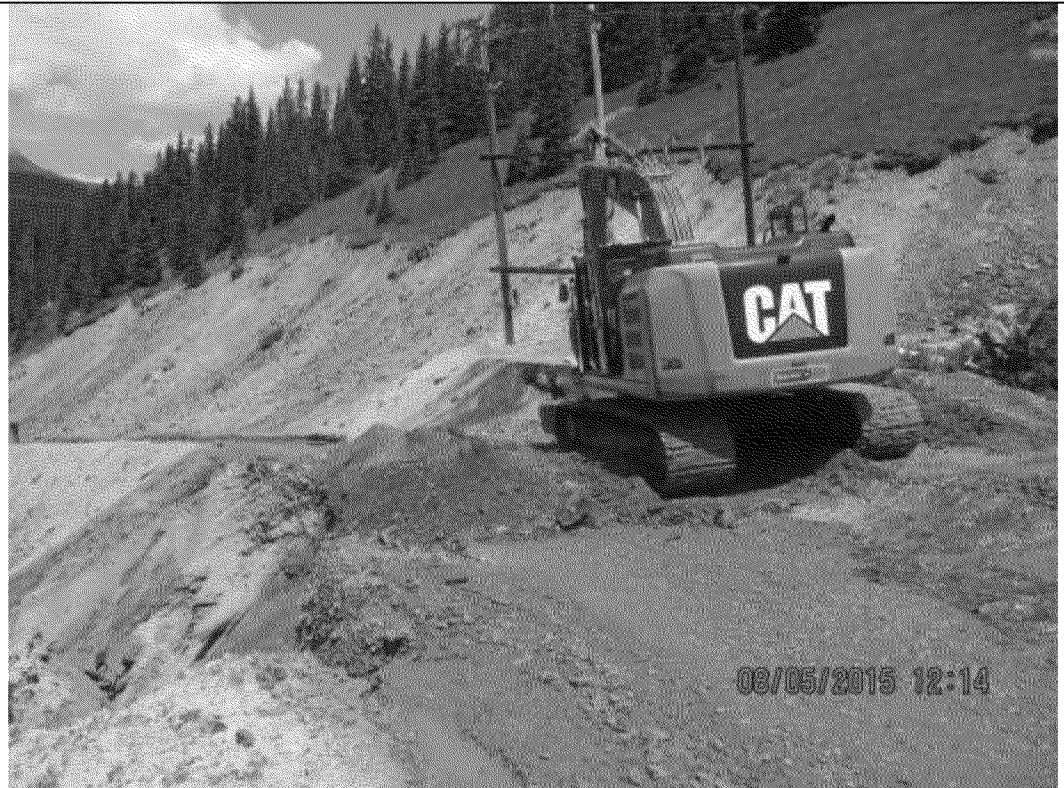
Photo No.
35

Excavator beginning work to secure safe exit route for equipment, vehicles, and personnel.

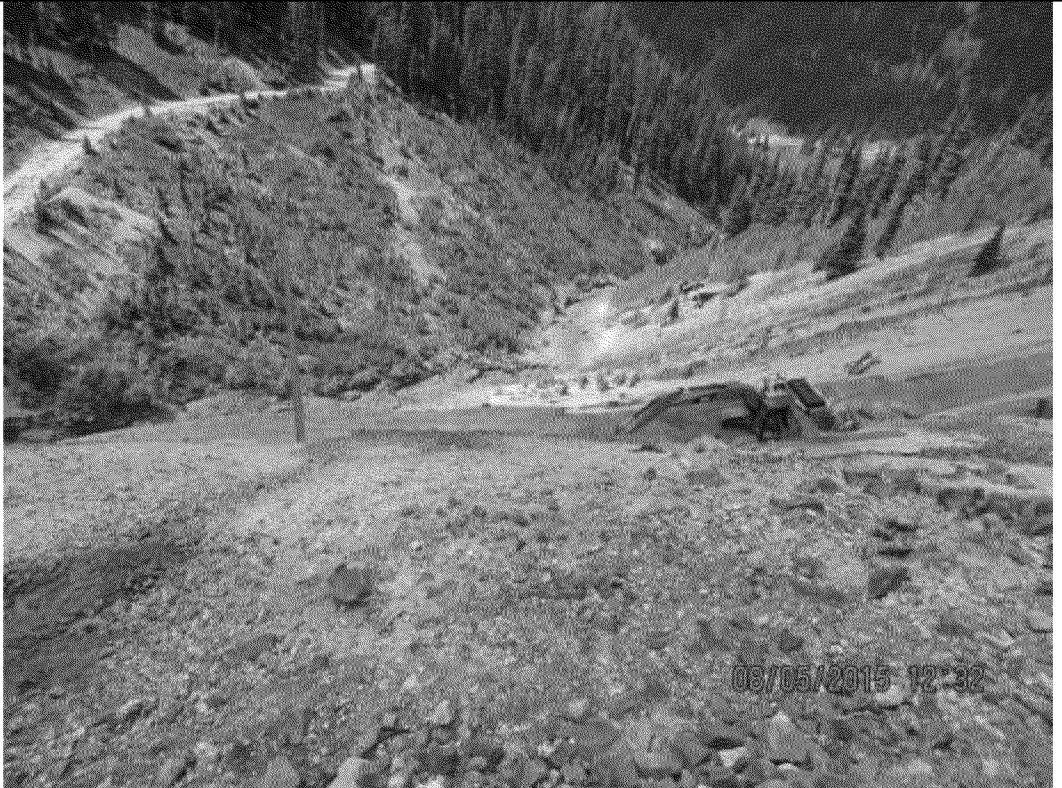
Photo No. 37	Date: 08/05/2015

Direction Photo Taken: Southwest/Down		
Description: Excavator progress on fixing access road to create a safe exit route.		
Photo No. 38	Date: 08/05/2015

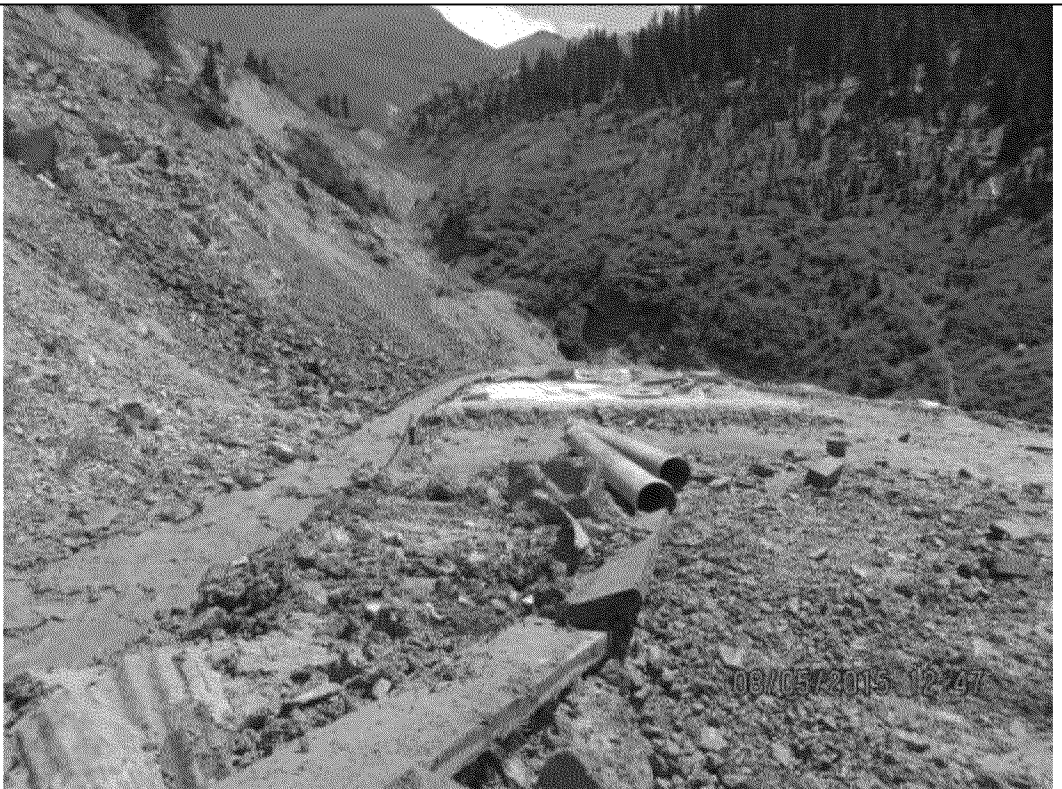
Direction Photo Taken: East		
Description: Existing culvert flows subsiding minimally.

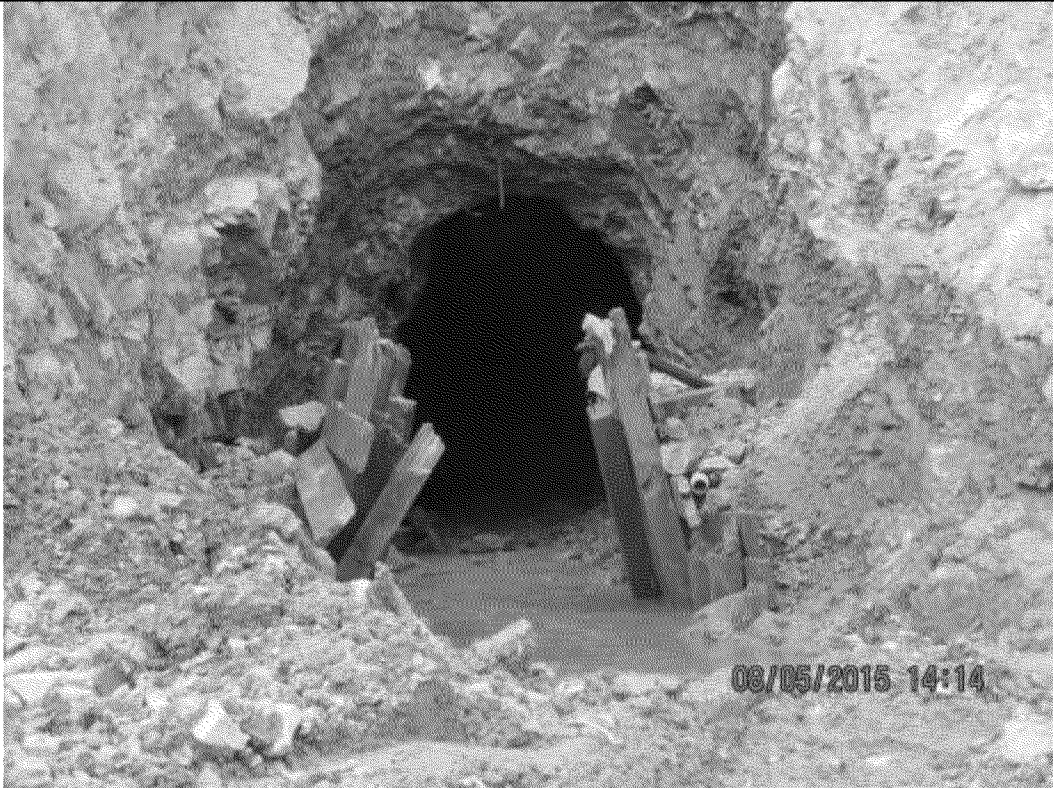
Photo No. 45	Date: 08/05/2015

Direction Photo Taken: North		
Description: Water levels lowering at adit entrance, no visible changes to structure.		
Photo No. 46	Date: 08/05/2015

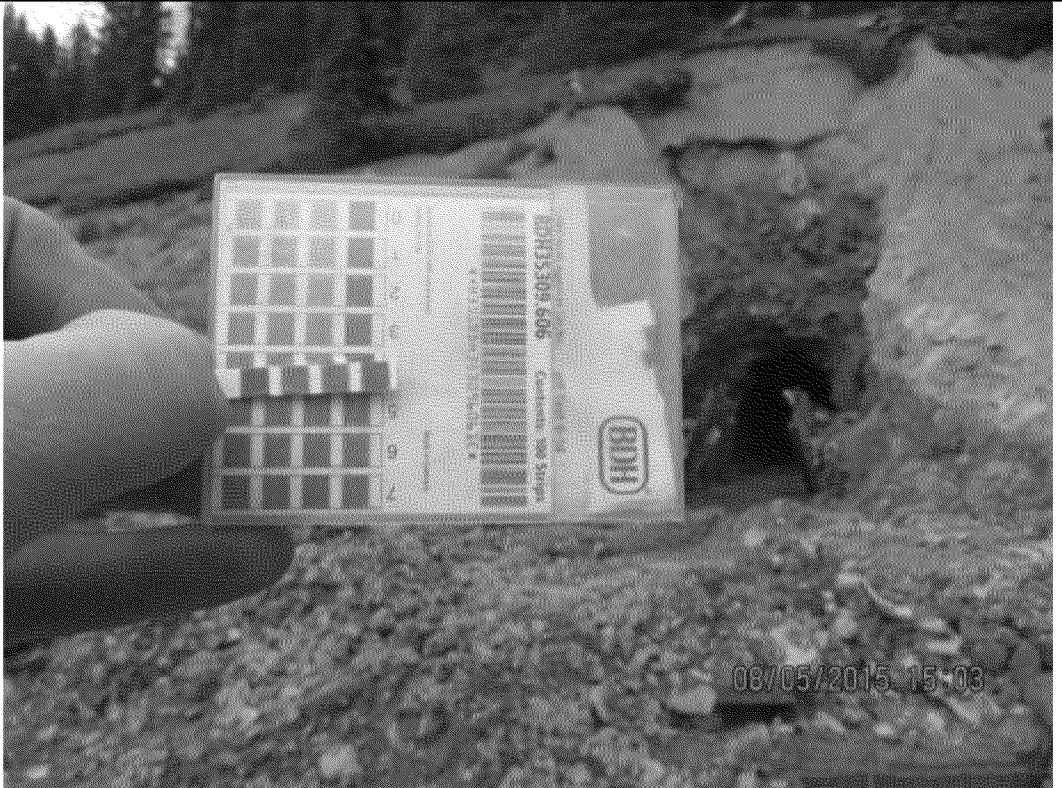
Photo No. 49	Date: 08/05/2015

Direction Photo Taken: North		
Description: pH measured at approximately 4.5.		
Photo No. 50	Date: 08/05/2015

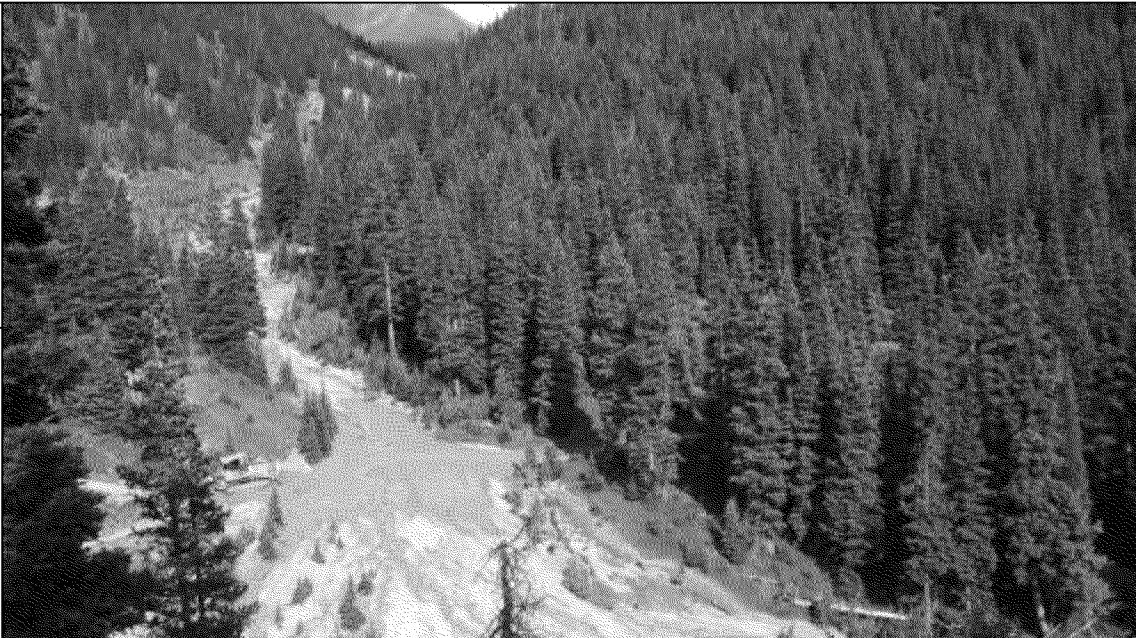
Photo No. 53	Date: 08/05/2015

Direction Photo Taken: East		
Description: Looking east across Cement Creek from County Road 10 to excavator fixing County Road 52 at North Fork crossing just south of Red and Bonita Mine.
